Inspection Report No: 4570

Client Name: ██████████
Property Address: 11 Village Bay Close, Marks Point.

The Standard Property Report (Except ACT) Complies with Australian Standard
AS 4349.1- 2007 Inspection of Buildings Part 1: Pre-Purchase Inspections –
Residential Buildings

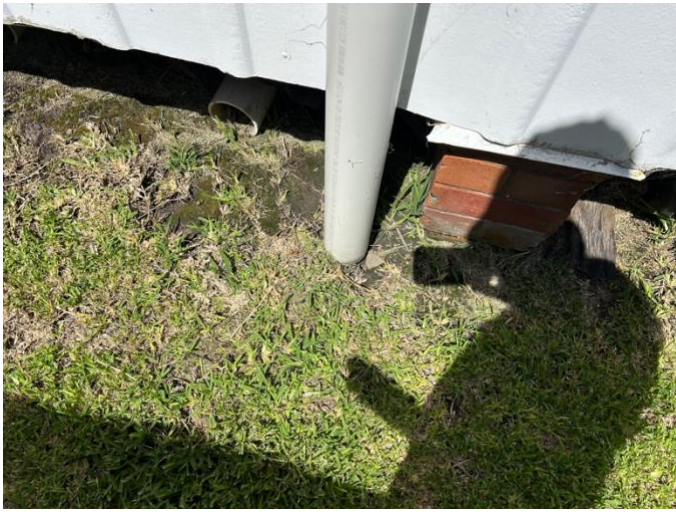
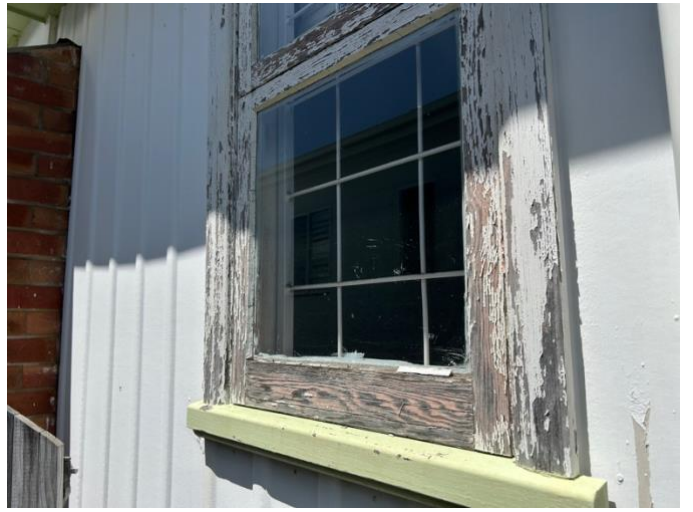
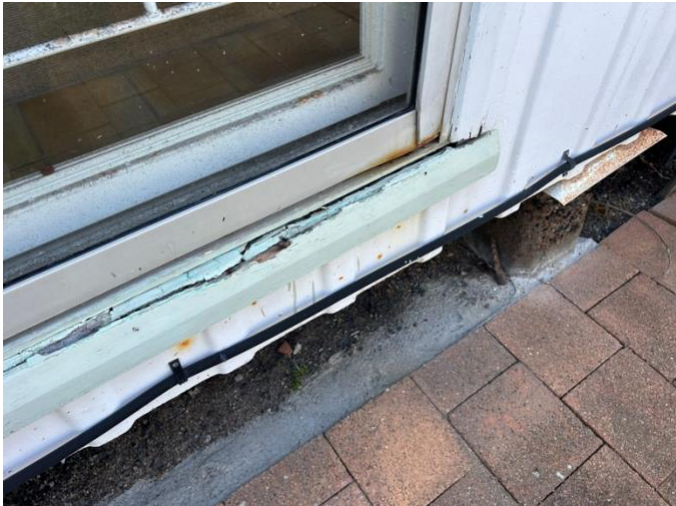
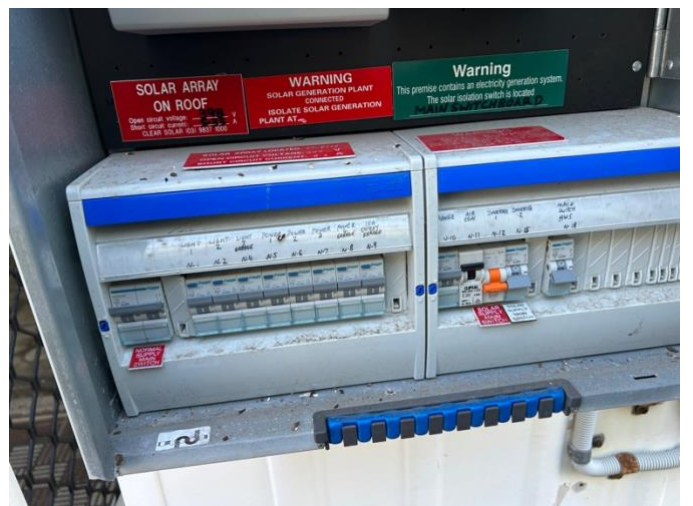
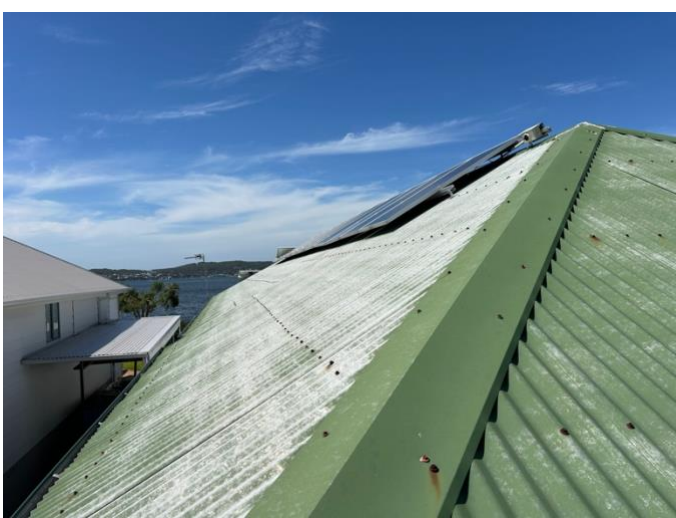
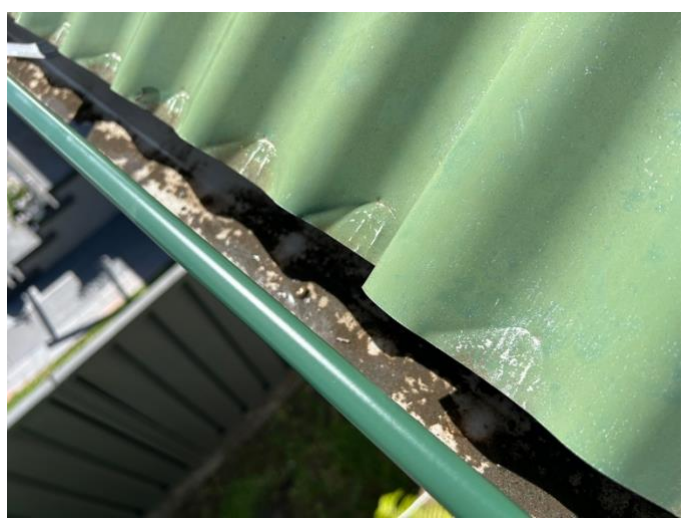
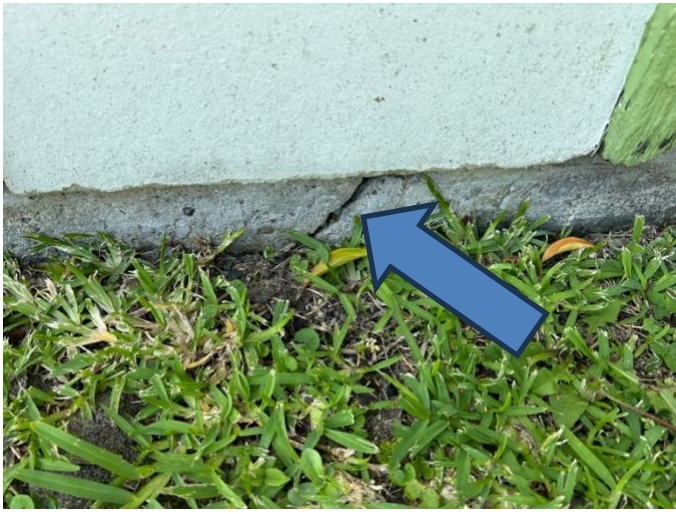
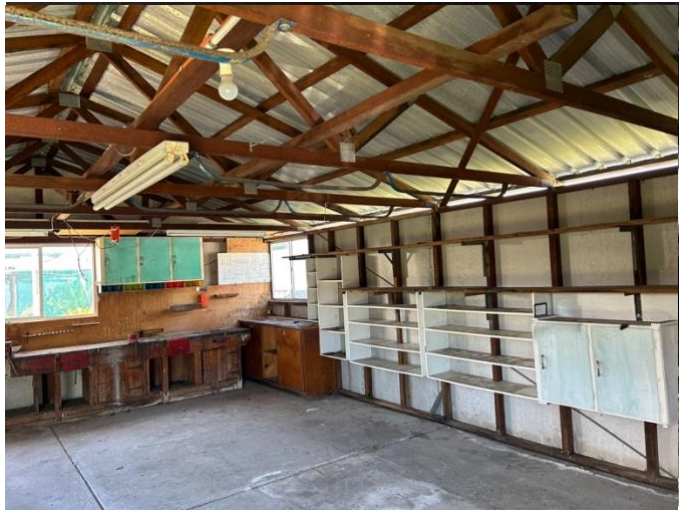
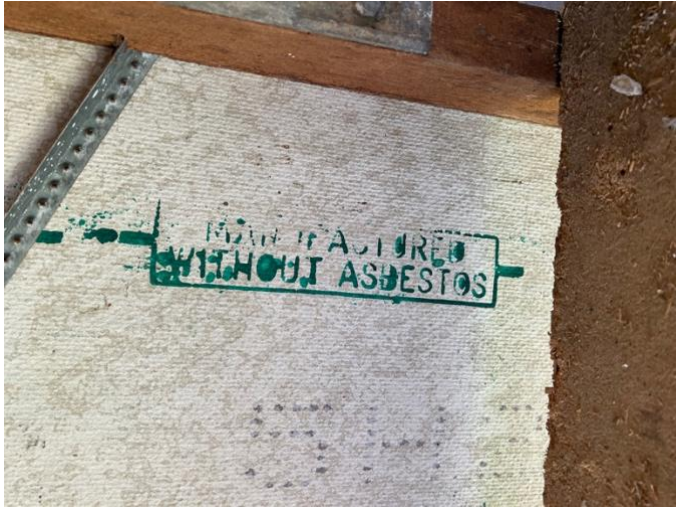
- Unconnected downpipes noted as per the summary. (Photo page 6)
- Areas of paint peeling to cladding and windows/storm moulds. (Photo page 6)
- 315lt electric HWS; date of manufacture 11/23.
- LPG gas provisions.
- Pier erosion noted as per the summary.

- Unconnected downpipes noted as per the summary.
- Areas of paint peeling to cladding and window storm moulds.
- Pier erosion noted as per the summary.
- Minor carpentry and painting repairs required to the sliding door storm mould. (Photo page 6)
- Areas of paint peeling to cladding and window storm moulds.
- Meter box; RCD safety switches protect selected power circuits only.

- The roof sheets and capping appear in generally good serviceable condition despite significant fading to the west/north facing sheets. (Photo page 6)
- Gutters and downpipes appear in generally good serviceable condition.
- Solar voltaic panels noted on the west and north elevations.
- Consider replacing corroded roof screws to prevent premature roof sheet replacement.

- No roof guttering fitted on the eastern elevation and unconnected downpipe noted on the western elevation.
- Minor cracking and settlement noted to the raft slab (typical). (Photo page 7)
- Power connected.
- No automatic openers fitted.

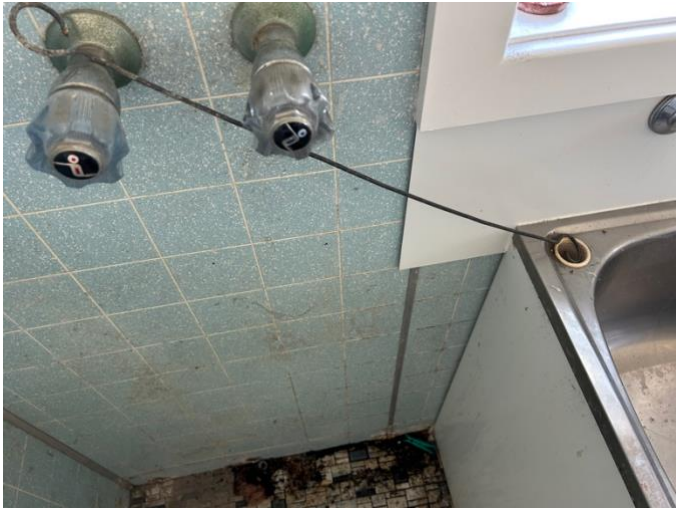
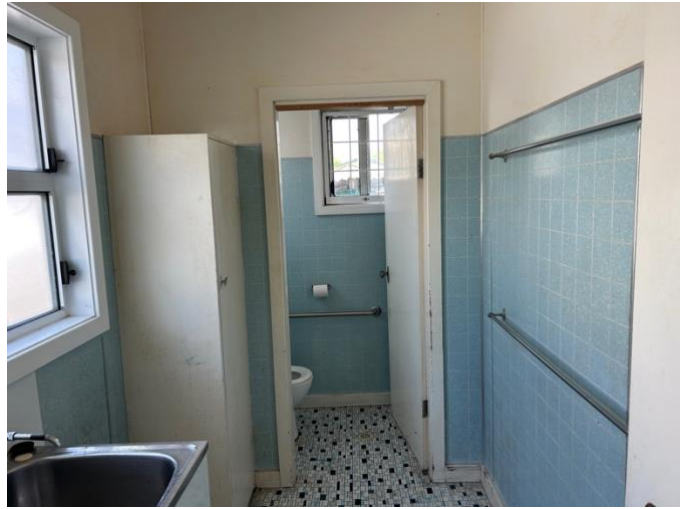
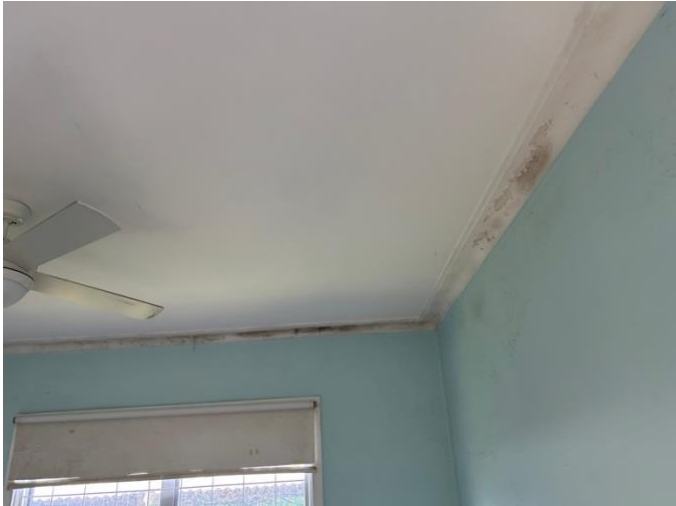
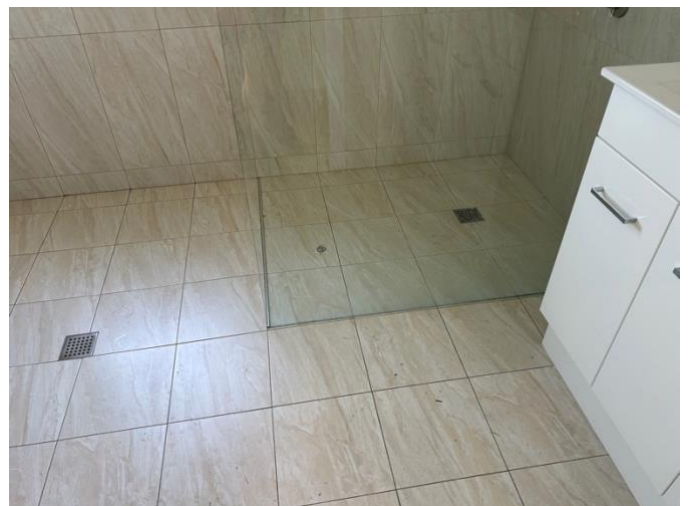
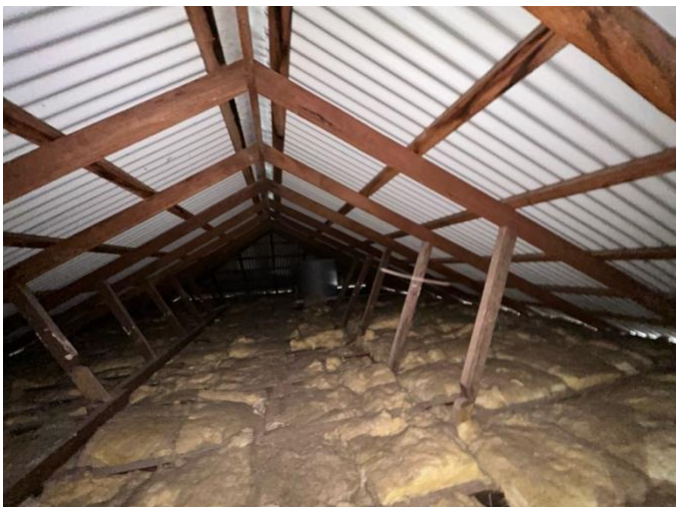
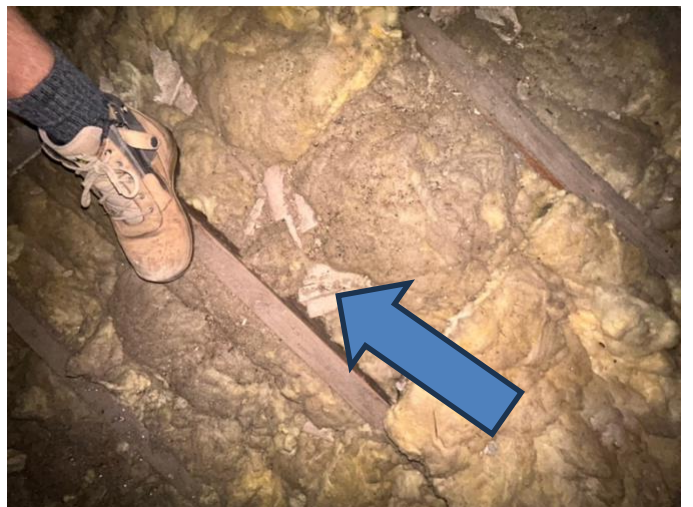
Pieces of the original asbestos roofing were evident in the roof cavity; removal by a qualified contractor is strongly recommended. (Photo page 10)

- Asbestos linings noted. (Photo page 10)
- Minor washer repairs required to washing machine tap to prevent water escape. (Photo page 10)
- Contractor sealant repairs required to the shower recess as per the summary.
- Shower recess flood tested.

- Spring replacements required to the double hung window sashes.
- Minor cracking noted to the ceiling lining.
- Prep and window, including mechanism replacements/repairs.
- Areas of mould noted to the cornice perimeters. (Photo page 10)

- No defects noted. (Photo page 10)
- Shower recess flood tested.

- Conventionally pitched hardwood roof frame appears generally sound and adequately braced despite minor deviations in the purlin timbers. (Photo page 10)
- Pieces of the original asbestos roofing were evident in the roof cavity; removal by a qualified contractor is strongly recommended. (Photo page 10)
- No insulation blanket fitted under the roof sheets. (Photo page 10)
- Insulation batts installed over the ceilings.
- No roof ventilation noted.

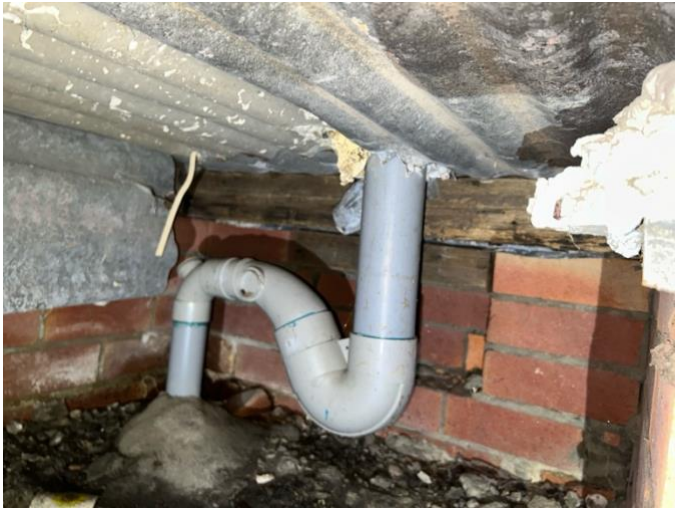
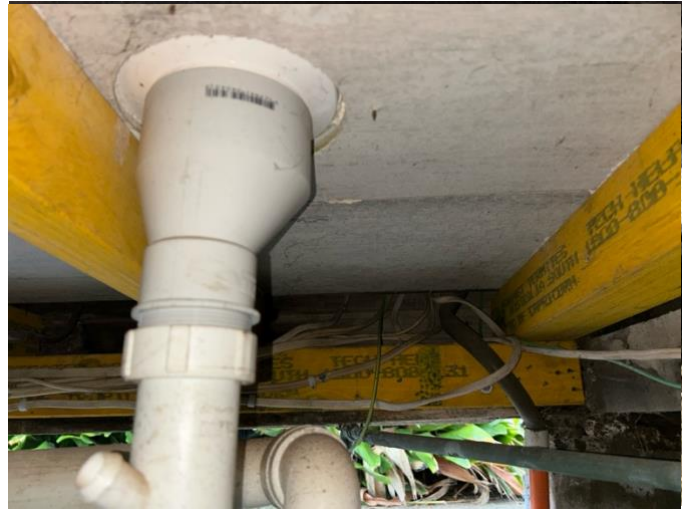
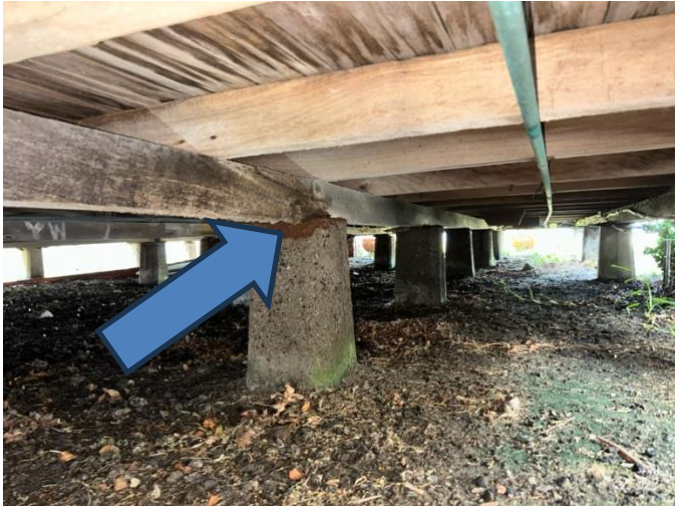
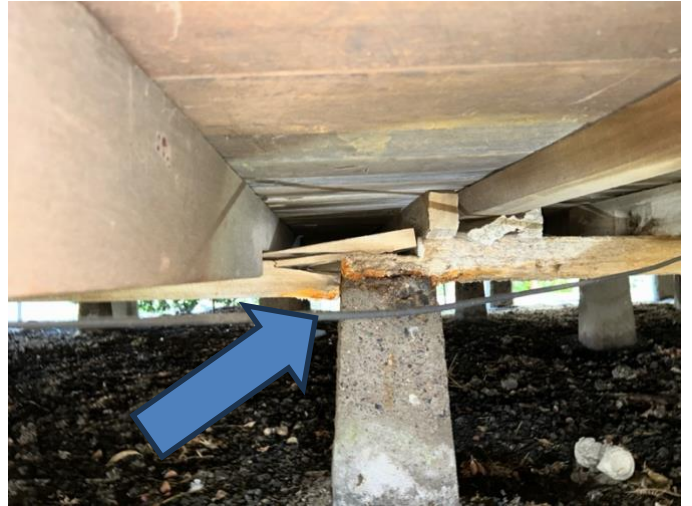
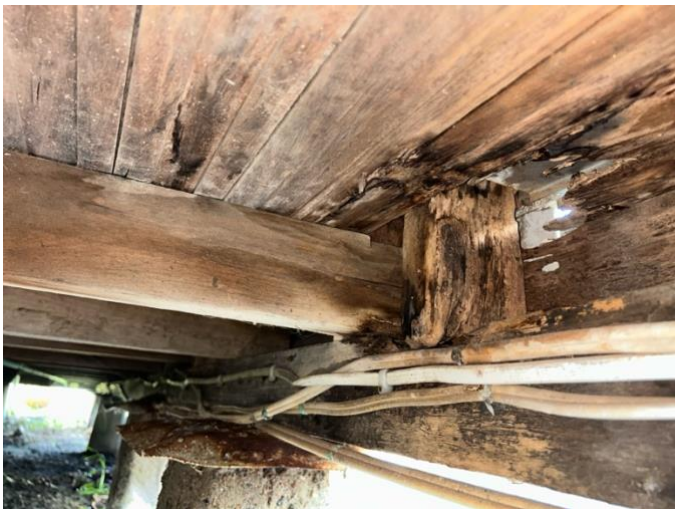
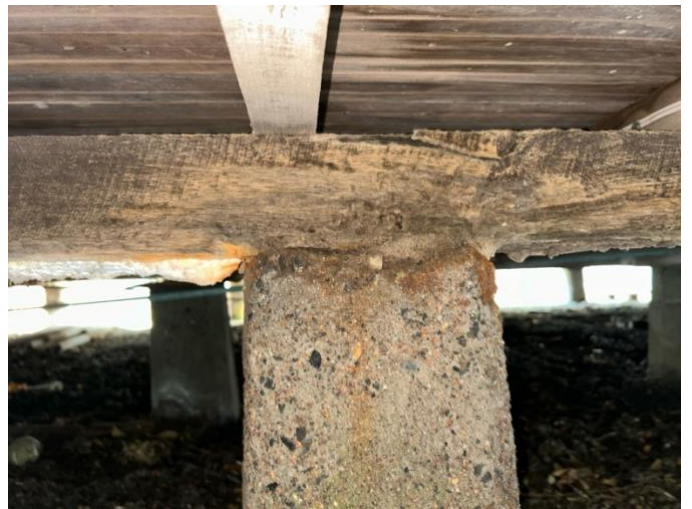
The building has been adequately maintained and appears in generally sound structural condition despite areas of minor to significant delignification (timber decay to the bearers adjacent the isolated piers.

The delignification has been caused by rising moisture via the isolated piers and extensively cored pier caps. Generally minor carpentry repairs will be required adjacent the affected areas, including replacing corroded caps. Consult a licensed bricklayer.

- Areas of delignification/decay noted to the bearer timbers as per the summary. (Photos page 11)
- Significant corrosion noted to the isolated pier caps as per the summary.
- Frame decay noted adjacent the east facing sliding door opening via original window structure decay. (Photo page 11)
- Minor to significant corrosion noted to the continuous sub-wall capping.
- No water escape noted from the shower recesses. (Photo page 11)
- Adequate ventilated.
- Light white/yellow surface mould noted adjacent the SE corner. (Photo page 11)
