# Inspection Report

## Allround Pest Management

**11 Village Bay Close, Marks Point, NSW, 2280**

## TIMBER PEST INSPECTION

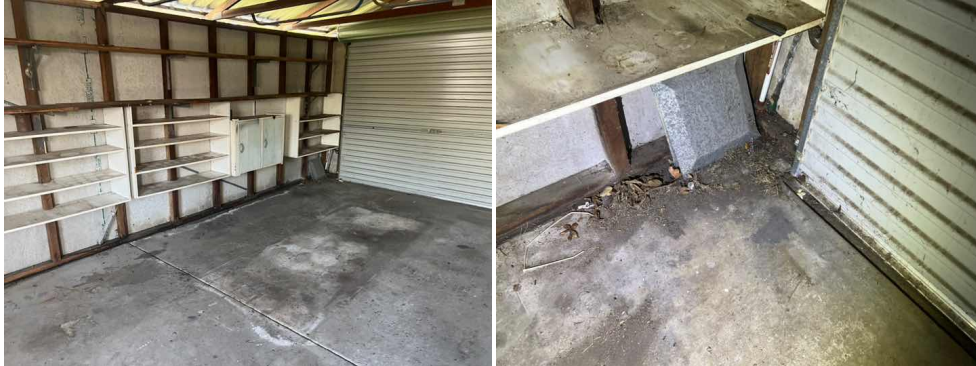
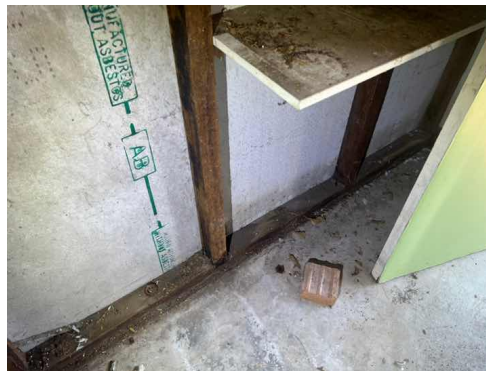
Garage timbers

Yes, in the following areas ,

Moderate Damage

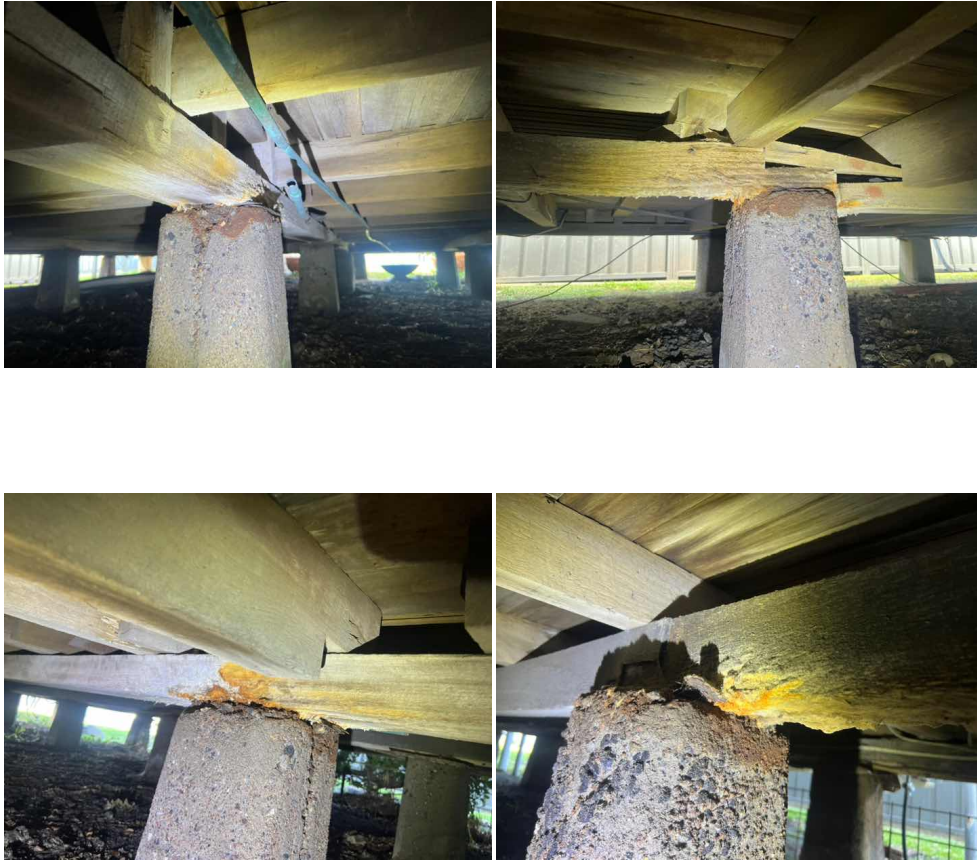
Yes, subfloor timbers

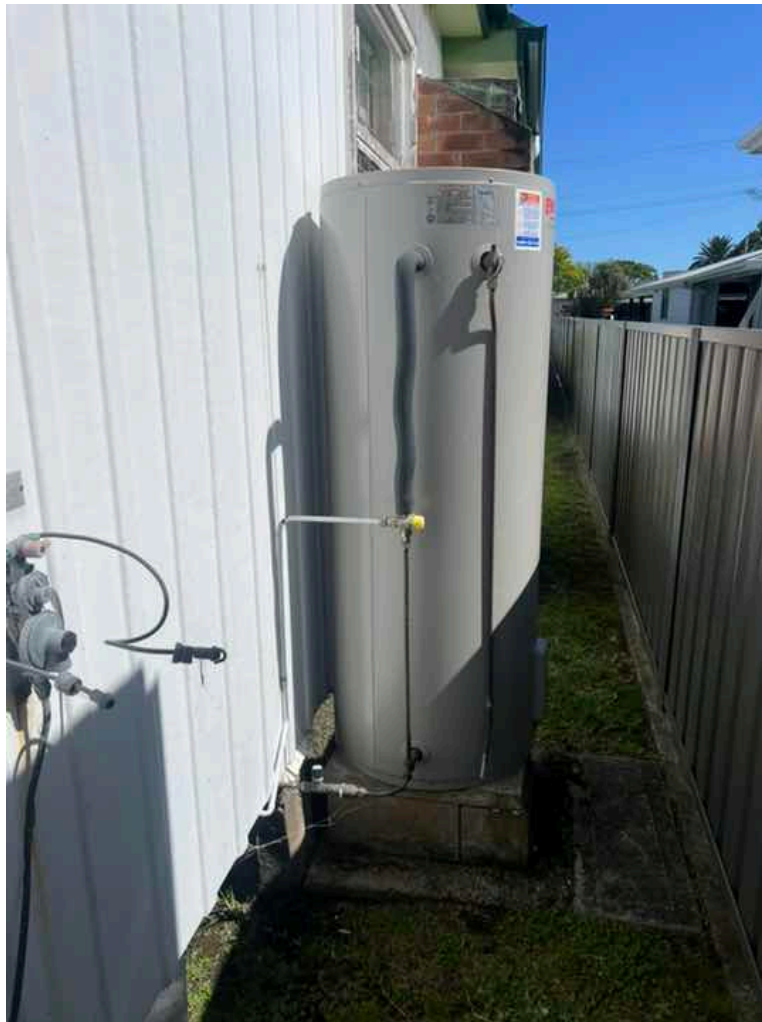
No - Divert hot water overflow away from the building perimeter

Hot water unit overflow not connected to drain. This provides conducive conditions for termite infestation.

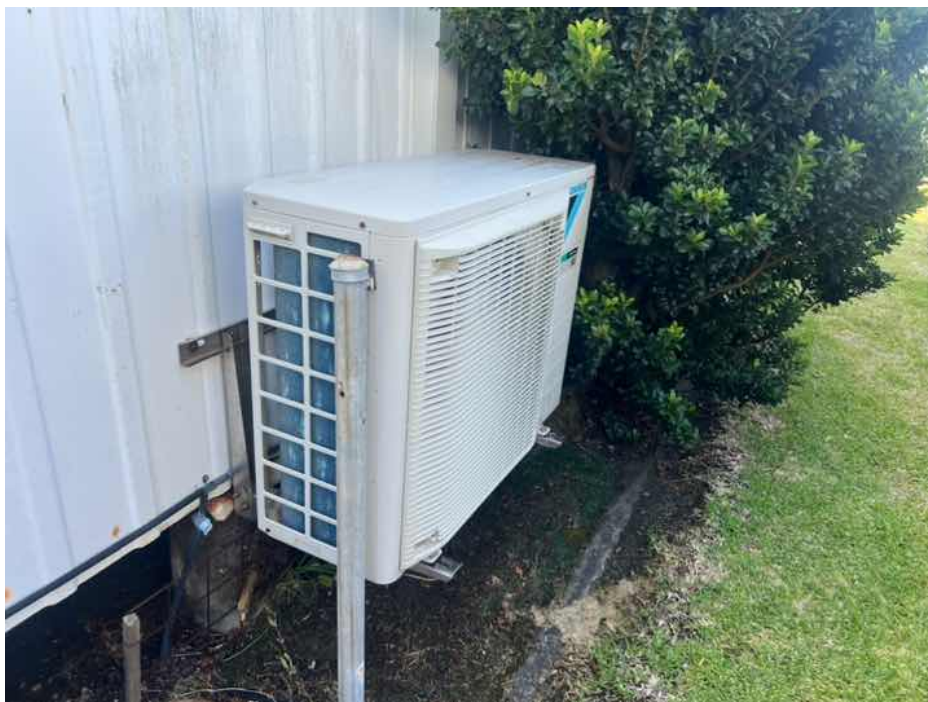
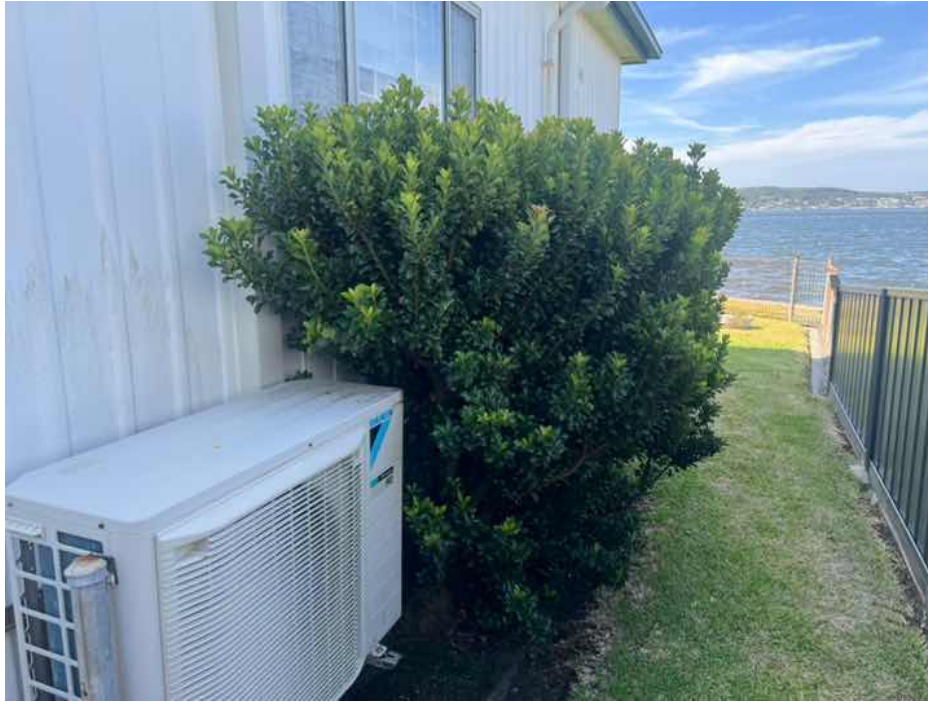
No - Divert A/C overflow away from the building perimeter

Wall mounted air conditioner overflow requires diverting to drain. This provides conducive conditions for termite infestation.

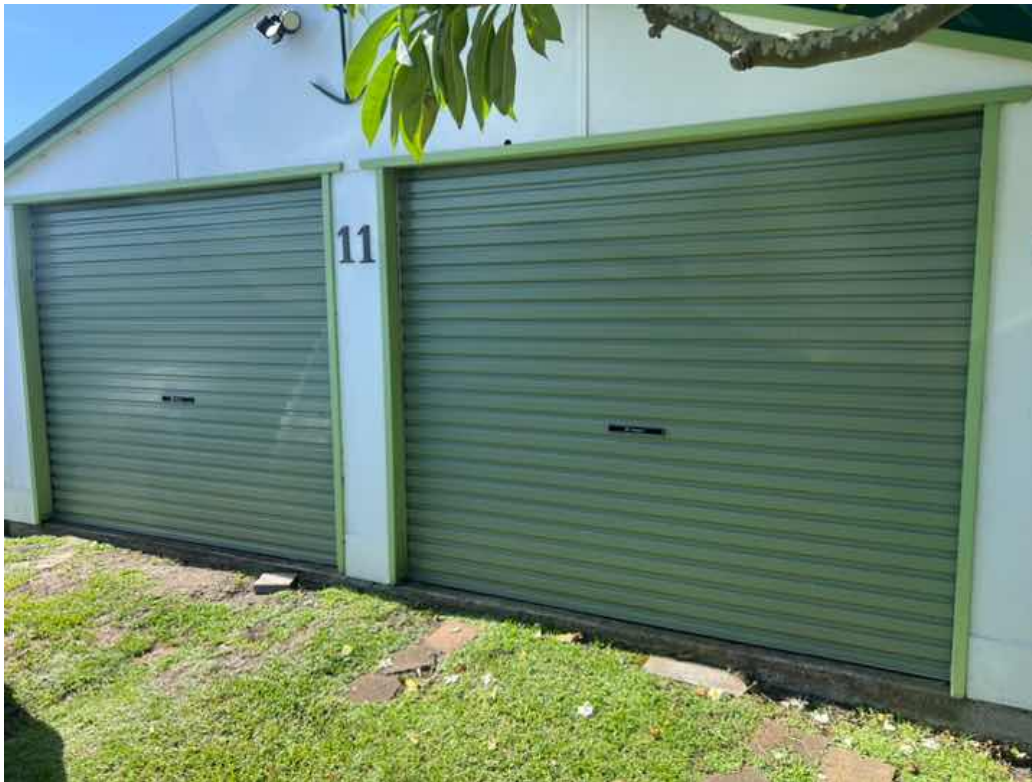
No. Slab edge should be exposed a minimum of 75mm.

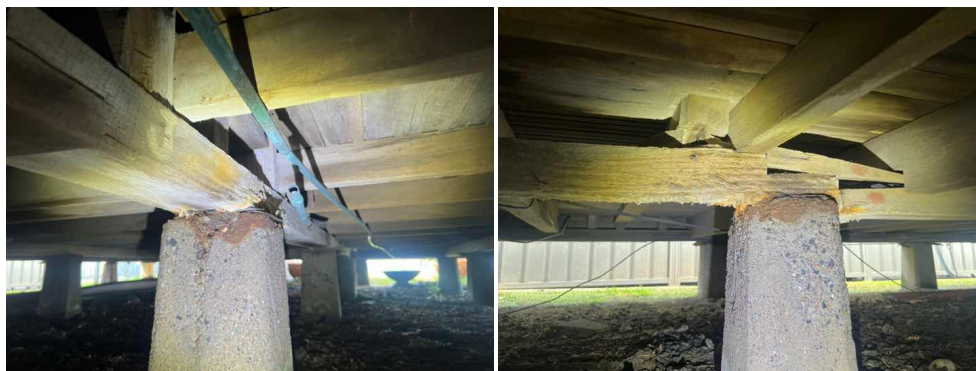
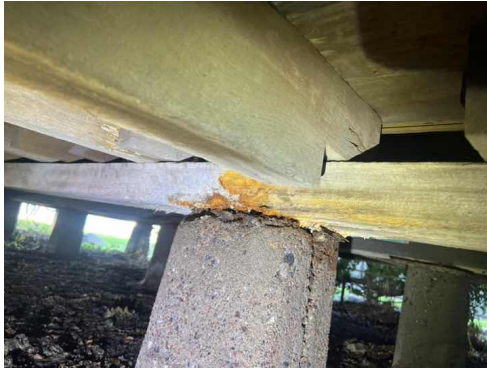
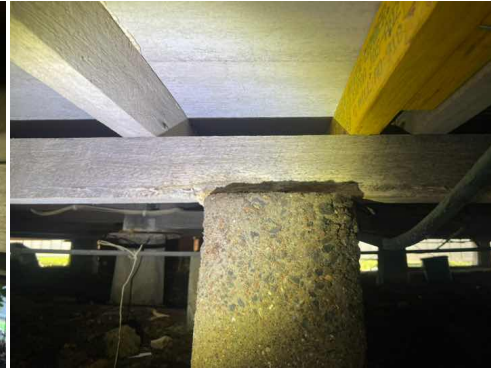
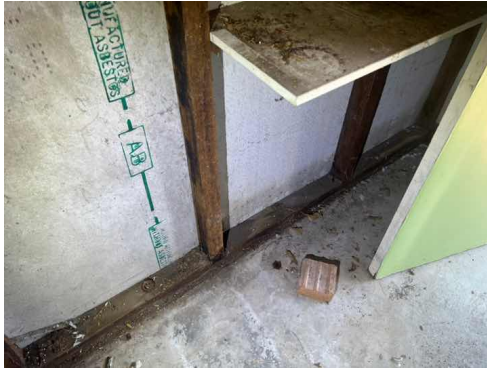
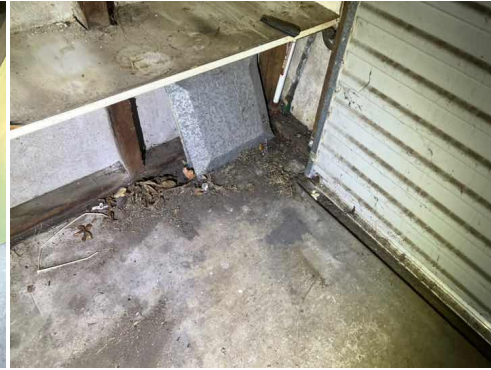
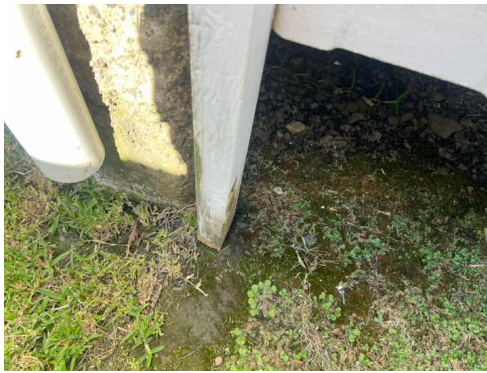
Timber debris in contact with ground in sub floor. This provides conducive and concealed conditions for termite infestation.

Timbers in direct contact with soil creates conducive conditions for termite attack. Timbers should be removed or replaced with a product resistant to termite attack.
